Sun Coast Marine
Surveying and Consulting

Marine Survey Report For Sample Survey
"2005 Hydra-Sport Vector 3300 CC"

18-331 2005 Hydra-Sport Vector 3300 CC

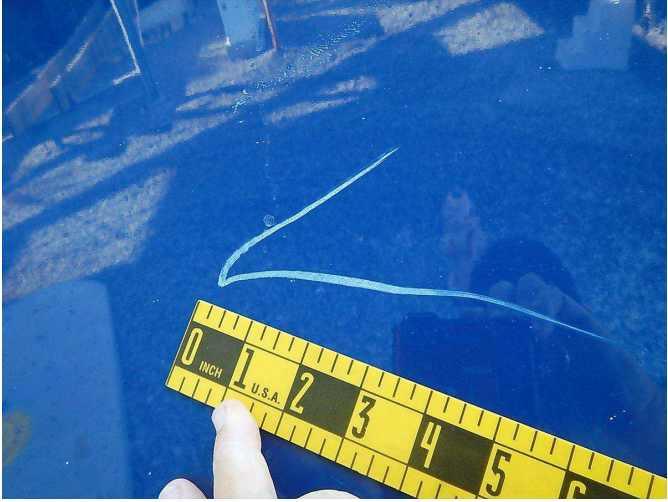
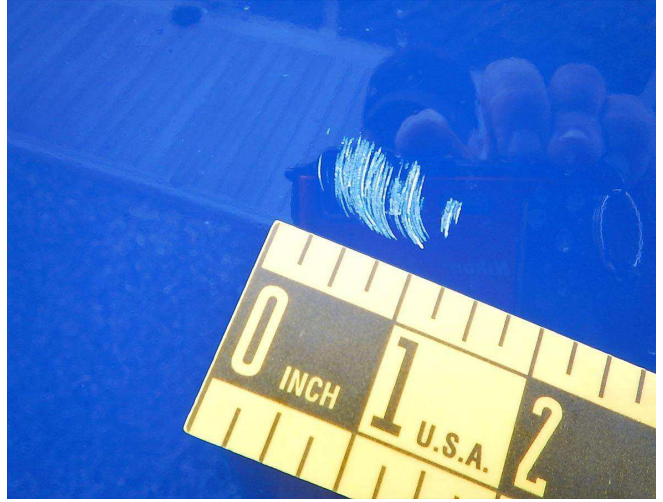
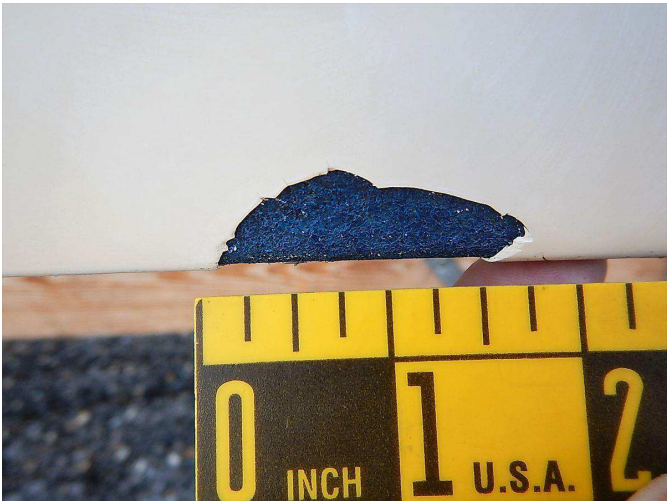
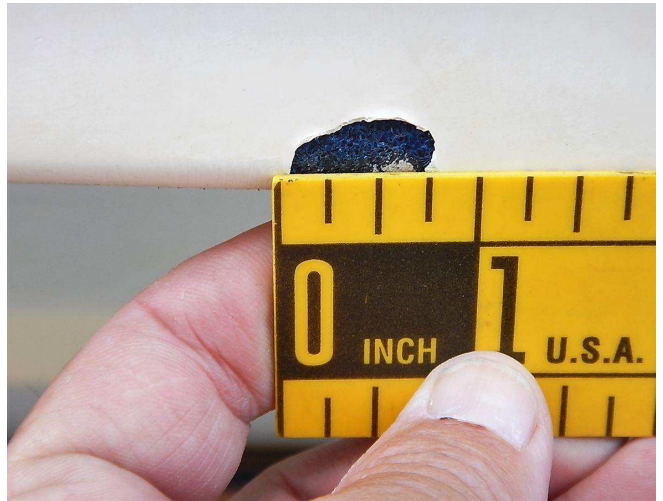
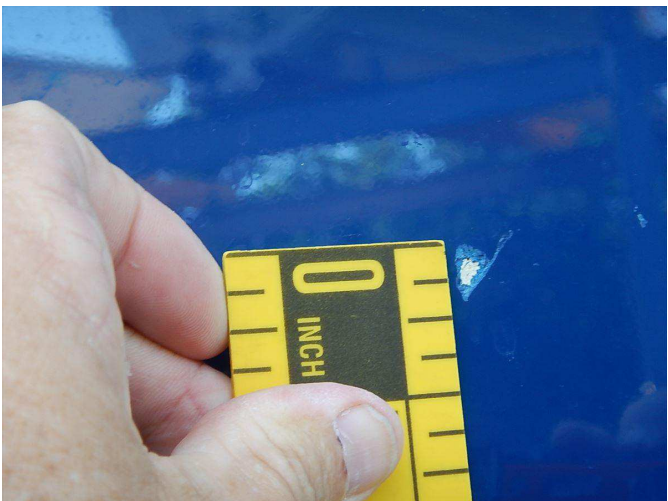
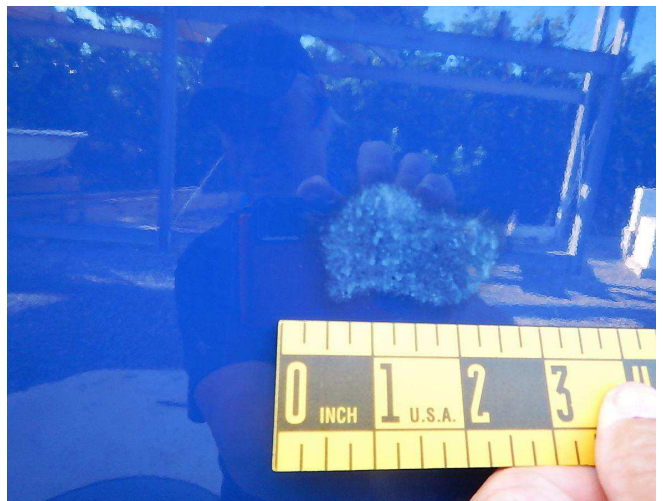
FINDING B-1 HULL, DECK & SUPERSTRUCTURE

Multiple scratches sighted on the above waterline topsides and several gelcoat chips sighted on the hull bottom where the bottom and the topsides meet on both port and starboard sides.

RECOMMENDATION

Repair gelcoat chips and scratches if desired.

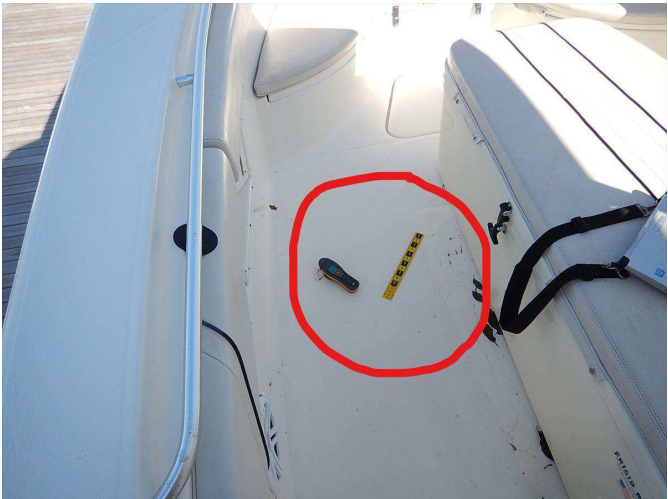
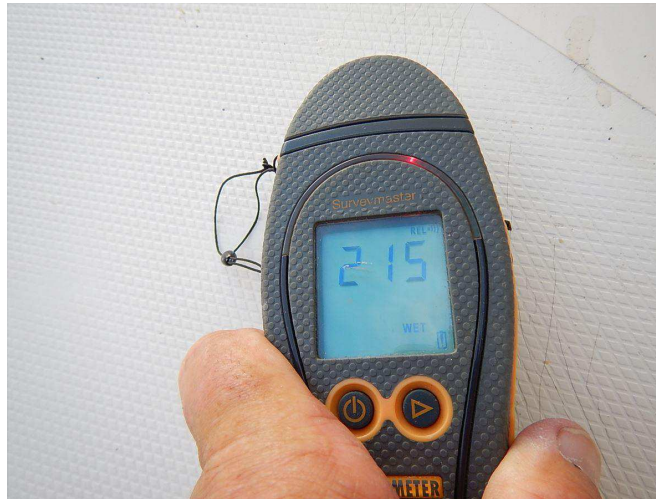
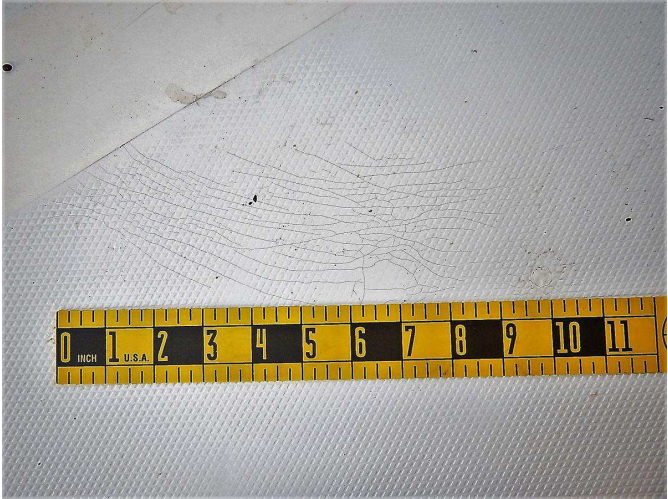
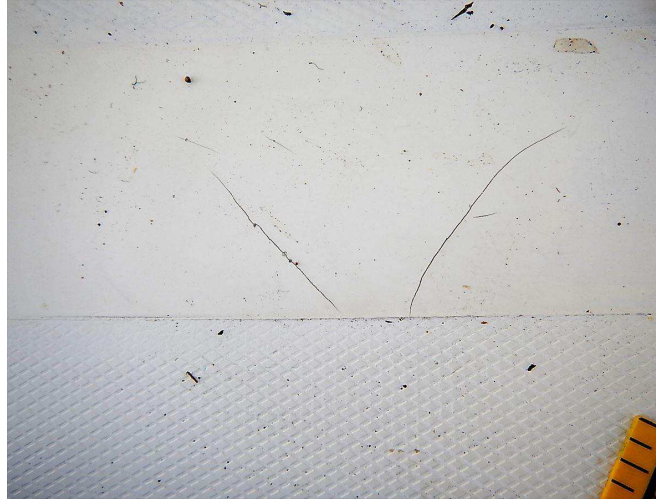
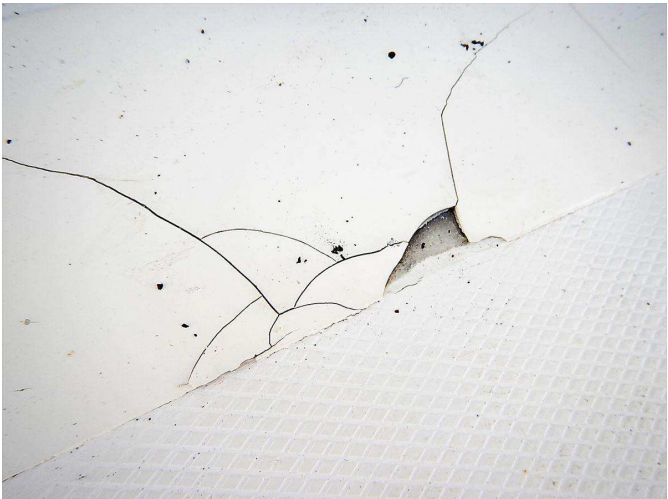
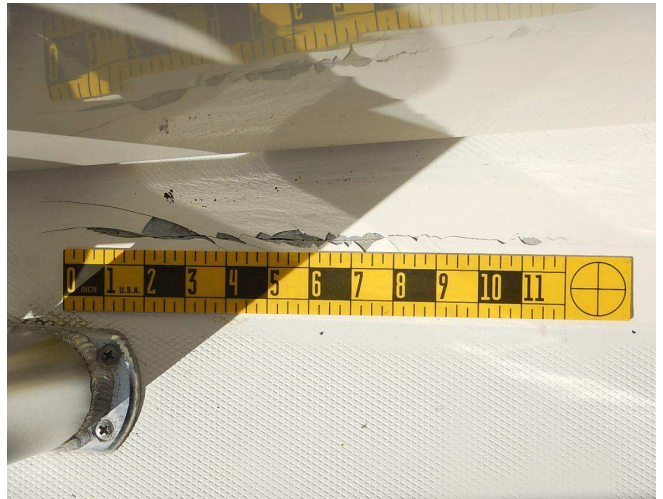
FINDING B-2 HULL, DECK & SUPERSTRUCTURE

On the port side deck foreword where the lounge/coffin box is located the deck is spongy/soft. Stress cracks can be sighted, percussion soundings were consistent with delamination and moisture meter readings were elevated consistent with moisture intrusion. Gelcoat cracking was sighted on both sides of the lounge back near the forward center console superstructure mounting brackets.

RECOMMENDATION

Investigate further damaged/delaminated and moist deck further and take action required to repair deck.

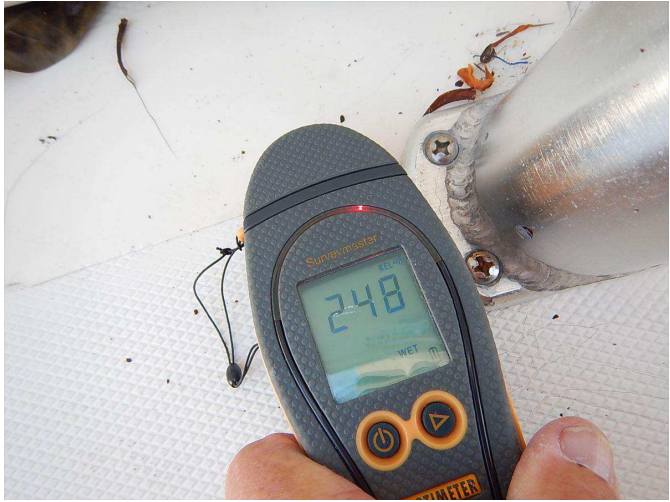
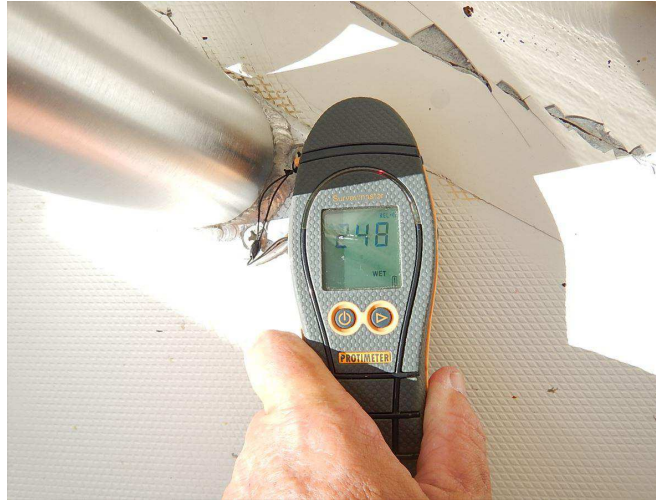
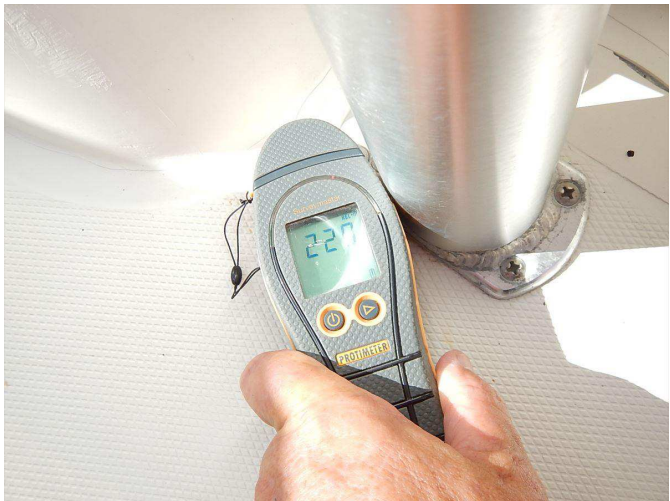
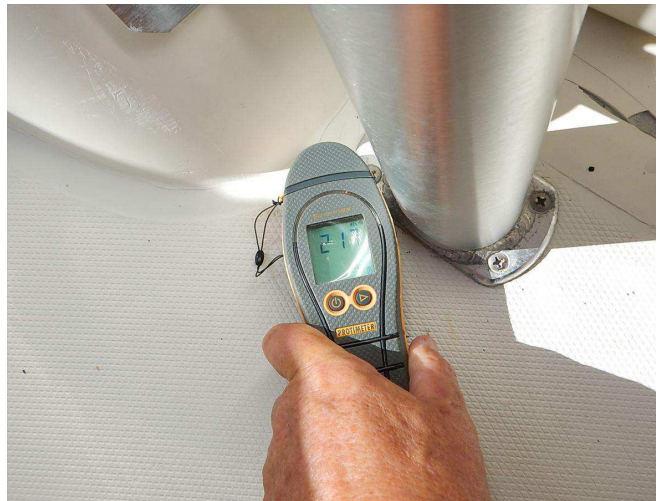
FINDING B-3 HULL, DECK & SUPERSTRUCTURE

Elevated moisture readings were taken at the center console superstructure where it mounts to the deck and the helm seat deck mounting positions.

RECOMMENDATION

Remove fasteners and re-bed to prevent moisture from getting into the deck.

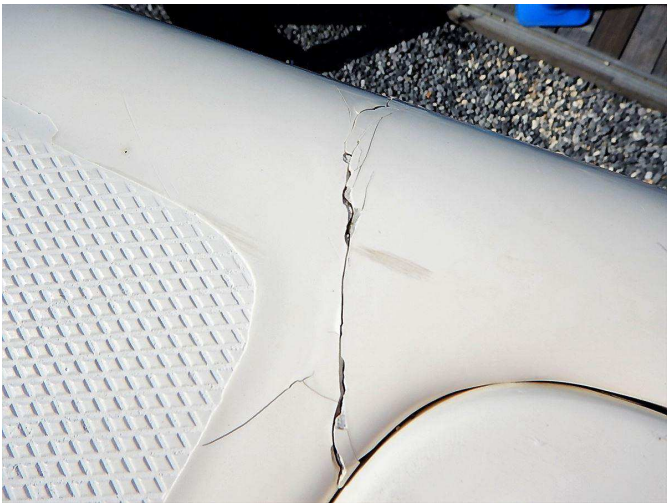
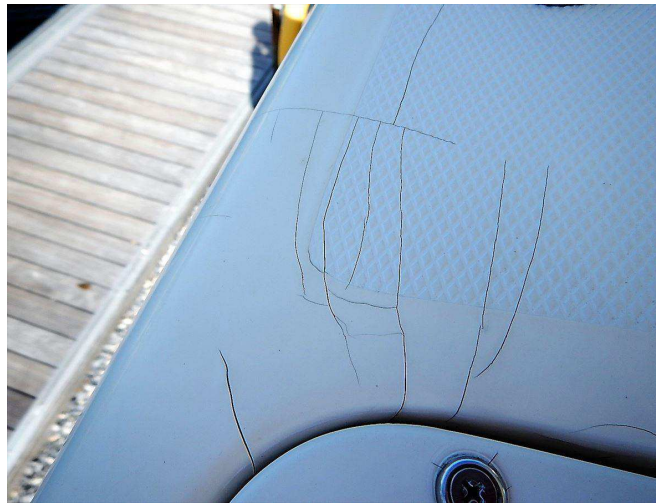
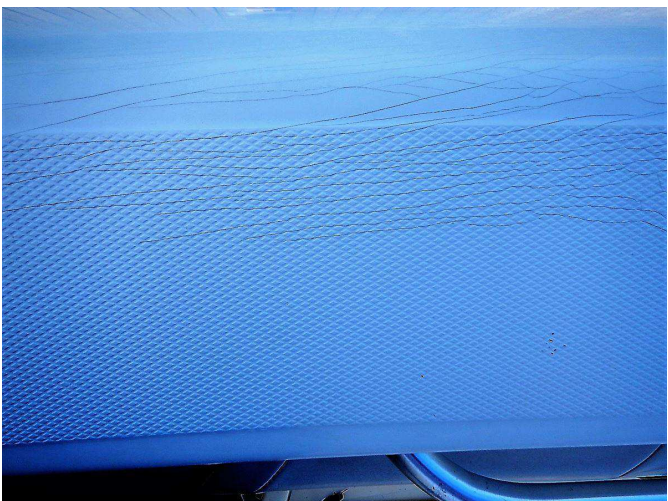
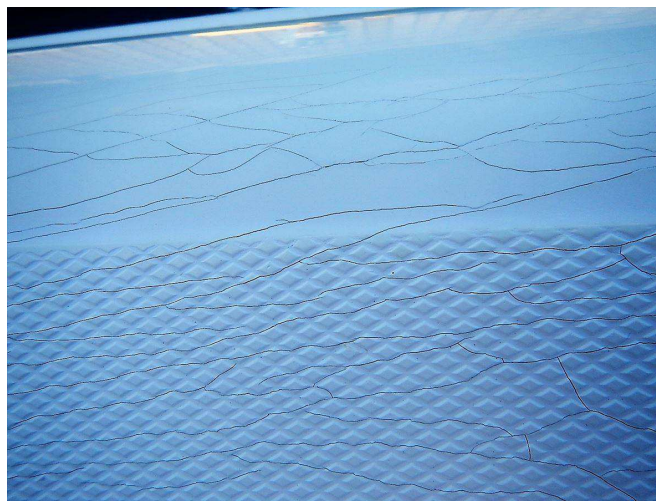
Gelcoat stress cracks sighted on the port and starboard gunnels.

RECOMMENDATION

Repair stress cracks if desired.

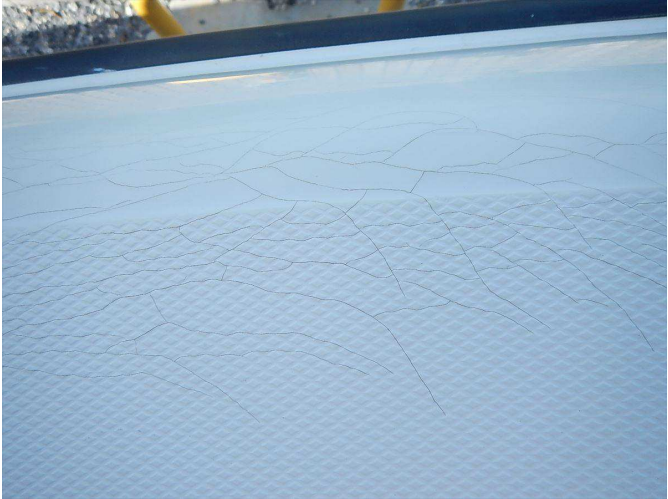
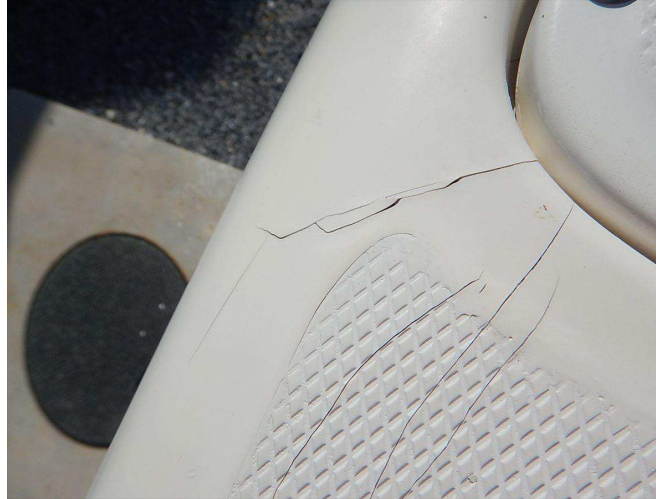
FINDING C-3 HULL, DECK & SUPERSTRUCTURE

Gelcoat stress cracks and gelcoat chips sighted on the deck.

RECOMMENDATION

Repair cracks and gelcoat chips if desired.
