Sun Coast Marine
Surveying and Consulting

Marine Survey Report For Sample Survey
"2005 Hydra-Sport Vector 3300 CC"

18-331 2005 Hydra-Sport Vector 3300 CC

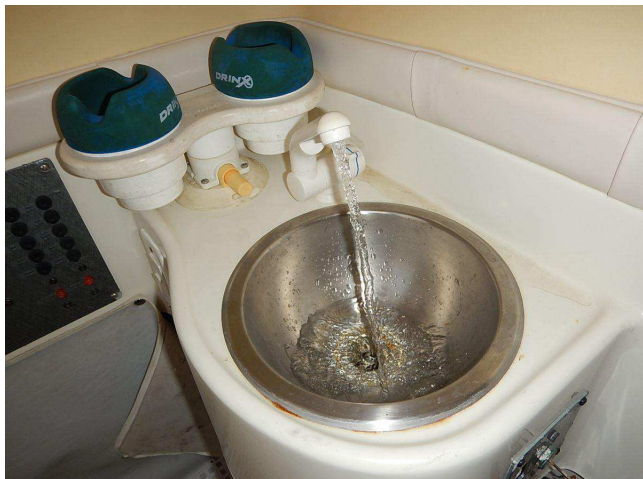
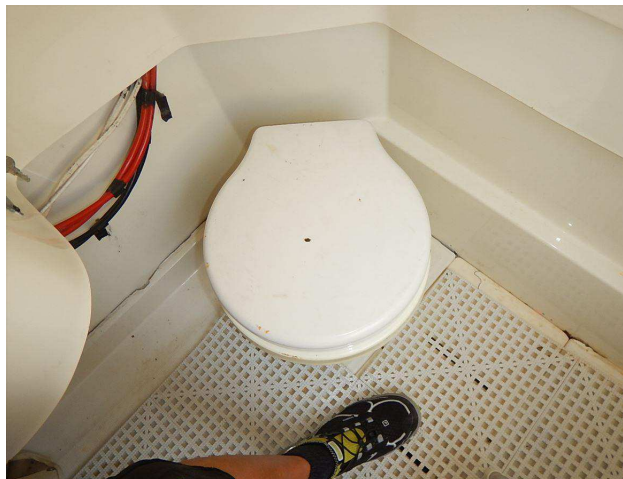
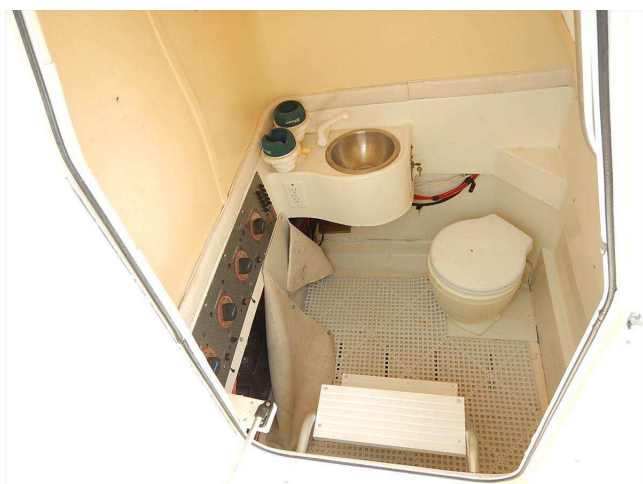
FINDING B-4

One water closet located inside the center console. Wash basin piped with flex hose and secured with a hose clamp to polished stainless steel faucet. An unknown brand marine head (Toilet) that operates on an electric flush system piped with reinforced hoses and secured with hose clamps. See Findings & Recommendations.

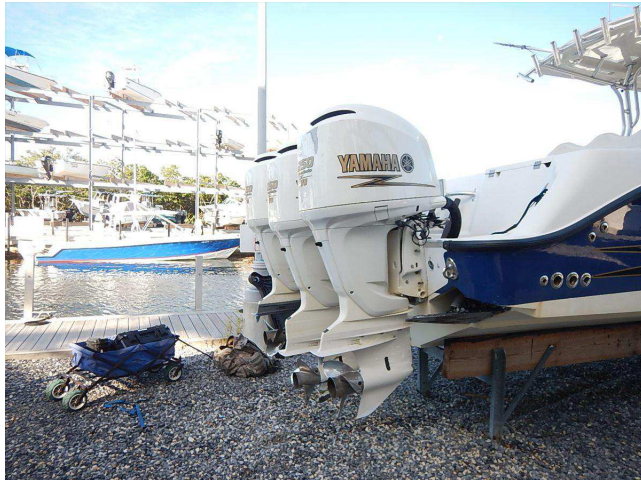
FINDING B-8

Three Yamaha 250 HP four stroke outboards. The engine mounts were secure. Both tilt and trim functions were operational when tested. Engine fluid levels were full and no metal shavings or emulsified oil sighted in the upper or lower unit. The props were stainless steel three bladed props. See Findings & Recommendations.

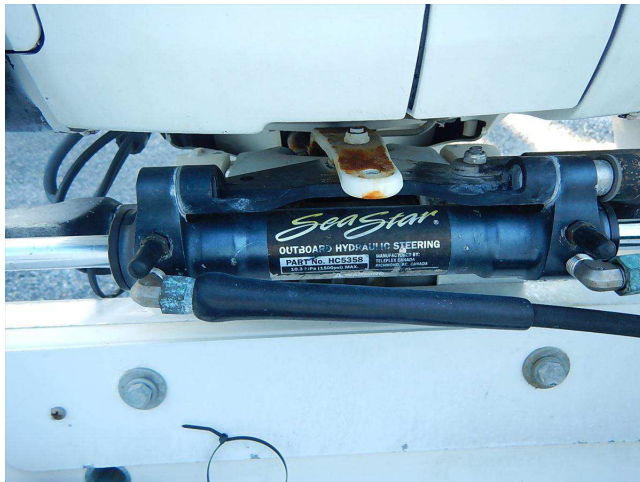
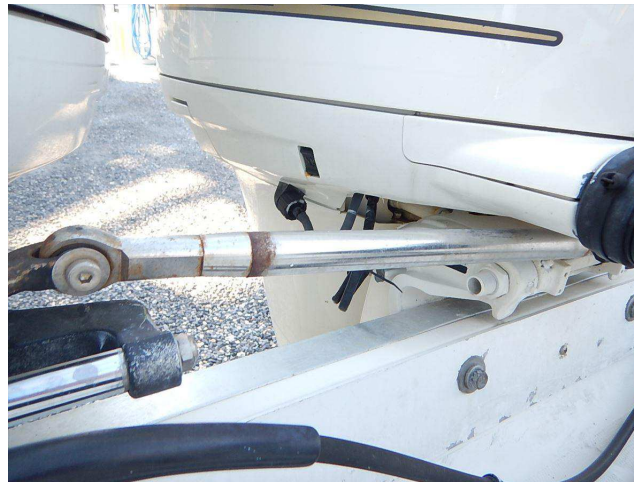
FINDING B-10

Helm pump wheel assembly, reinforced steering system hoses, hydraulic ram, stainless steel drag link with clevis ends. See Findings & Recommendations.

Note: Upon purchase of a used vessel this company suggests, the steering system is serviced according to the manufacturer's recommendations as a preventive measure and inspected regularly thereafter as part of a regular on-going maintenance program.

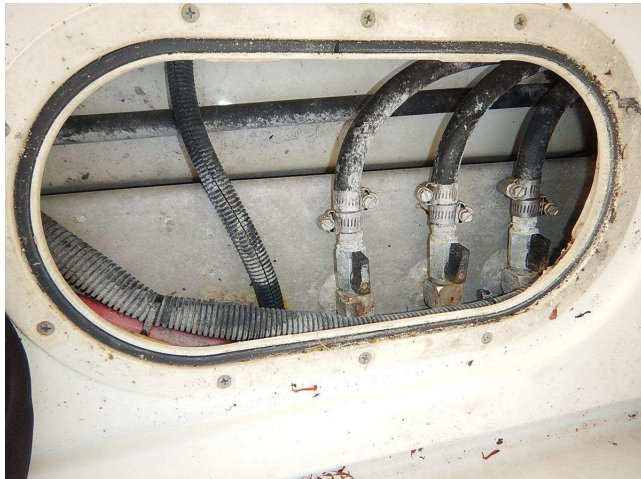
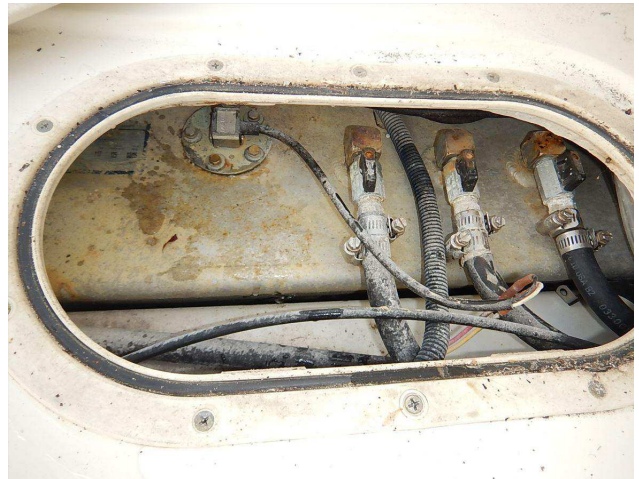
Three tanks located with two in the aft port and starboard side and one below the helm seat all below the deck with visible manufactures labels. Unknown how the tanks were secured due to visibility. Grounding conductors were not observed at the tanks and pipe to weather deck mounted stainless steel pipes marked for gasoline. Continuity testing was performed using a multimeter and the results were consistent with tanks and fills that are grounded. The fill hoses were USCG approved Type A hoses secured with double hose clamps where visible. The tanks were vented to topside mounted fittings with flame screens and were plumbed with SAE j1527 hoses secured with hose clamps. The fuel supply and return hoses were also SAEj1527 with swaged mechanical fittings, and the engines were equipped with OEM type flexible fuel lines and metal fuel tubing. Fuel filtration was provided by three remotely mounted primary fuel filters and engine mounted OEM type fuel filters. Fuel shutoff valves were sighted on tank tops. Tanks appear to be original and in serviceable condition.

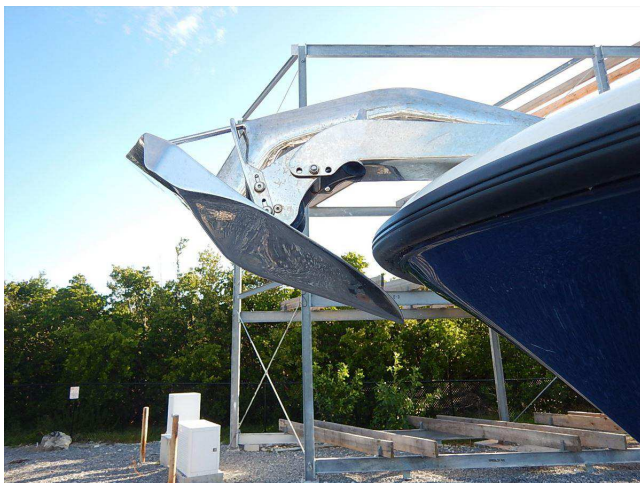
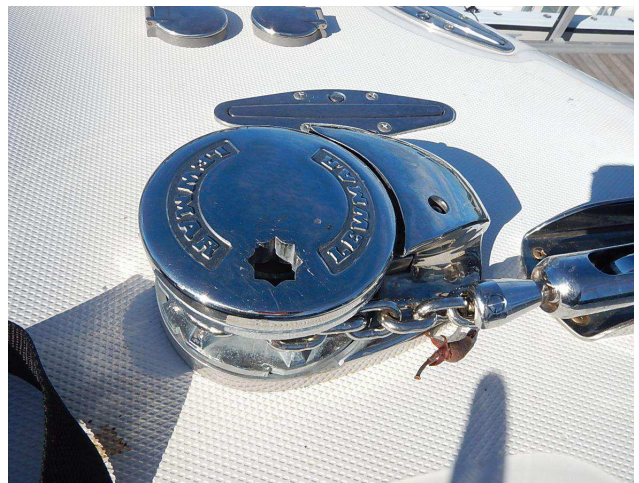
Primary: A polished stainless steel 35lb Ultra anchor is mounted at the anchor platform with an undetermined length of raw chain and considered serviceable other than noted in the Findings & Recommendations, showing moderate wear and wastage.

Secondary: An aluminum FX7 anchor is stowed in the anchor locker with an undetermined length of raw chain. A standard anchor shackle properly seized and considered serviceable other than noted in the Findings & Recommendations, showing moderate wear and wastage.

Windlass: A Lewmar windlass is mounted on the platform and was functional using both the helm and the bow foot controls.
